### Notice of Receipt of Third-Party Committee Investigation Report

**Investigation Report  
(Summary Version)**

November 21, 2024

Kyushu Railway Company Third-Party Committee

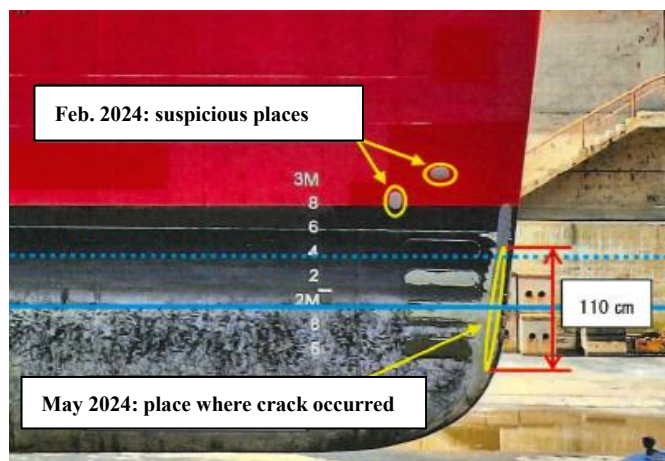
**Fig.: Positions and Forms of Places and Crack Suspected of Being the Cause of Flooding**

Subsequently, it was confirmed at the dock that there were cracks in a total of four places, and all were places where slot welding had been carried out from the outside in order to attach the bow starboard side outer plate.

When the *Queen Beetle* was subsequently docked and the hull was checked, a crack was found in the bow starboard side outer plate slot welding, and thus reinforcement repair was performed by attaching five sheets of doubler plates as reinforcement plates<sup>7</sup>. After this repair was completed, the *Queen Beetle* resumed operations on January 25, 2024.

On May 30, 2024, an instruction to immediately suspend operation of ferry services was received from the Kyushu District Transport Bureau and a diver check was conducted, with the latter finding a vertical crack of around 110 cm on the starboard side, in a location near the front of the bow. This crack occurred along a welded section on an outer edge of the starboard side outer plate.

As concerns the Flooding, as of February 20, 2024, when the bow starboard side outer plate was investigated in a boat check, slight cracks were discovered in two locations in a slot welded portion; and in the bow compartment flooding that occurred on January 4, 2024 (“**January 2024 Flooding**”), while the flooding volume was not particularly different, cracks in the bow starboard side slot welded portions were the cause. In light of these and other circumstances, it must be said that as of February 20, 2024 at the latest, it was highly likely that the cracks were the cause of the flooding and circumstances were such that “damage to the vessel” should have been suspected.
