(Correction) Notice of Partial Correction to  
“Notice of Receipt of Third-Party Committee Investigation Report”

**Investigation Report  
(Summary Version)**

Kyushu Railway Company Third-Party Committee

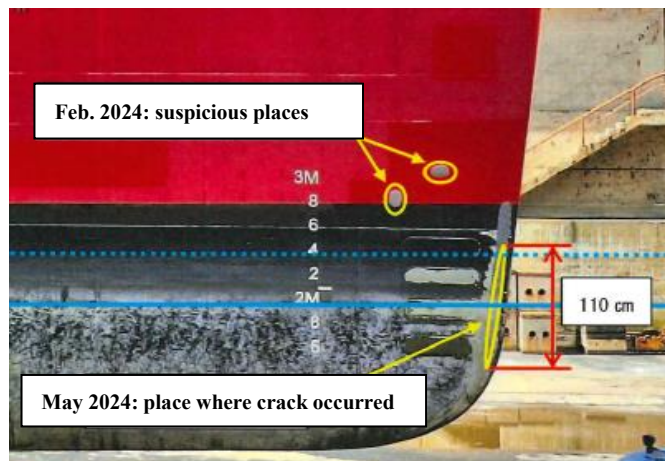
**Fig.: Positions and Forms of Places and Crack Suspected of Being the Cause of Flooding**

Subsequently, it was confirmed at the dock that there were cracks in a total of four places, and all were places where slot welding had been carried out from the outside in order to attach the bow starboard side outer plate.

On May 30, 2024, an instruction to immediately suspend operation of ferry services was received from the Kyushu District Transport Bureau and a diver check was conducted, with the latter finding a vertical crack of around 110 cm on the starboard side, in a location near the front of the bow. This crack occurred along a welded section on an outer edge of the starboard side outer plate.

As concerns the Flooding, as of February 20, 2024, when the bow starboard side outer plate was investigated in a boat check, slight cracks were discovered in two locations in a slot welded portion; and in the bow compartment flooding that occurred on January 4, 2024 (“**January 2024 Flooding**”), while the flooding volume was not particularly different, cracks in the bow starboard side slot welded portions were the cause. In light of these and other circumstances, it must be said that as of February 20, 2024 at the latest, it was highly likely that the cracks were the cause of the flooding and circumstances were such that “damage to the vessel” should have been suspected.

When the *Queen Beetle* was subsequently docked and the hull was checked, a crack was found in the bow starboard side outer plate slot welding, and thus reinforcement repair was performed by attaching five sheets of doubler plates as reinforcement plates<sup>7</sup>. After this repair was completed, the *Queen Beetle* resumed operations on January 25, 2024.
